Manhole Inspection Summary

Manhole # S43SS_012MH

Insp Date: **2/27/07 8:34 AM**

Location Address: **2648 POLK ST**

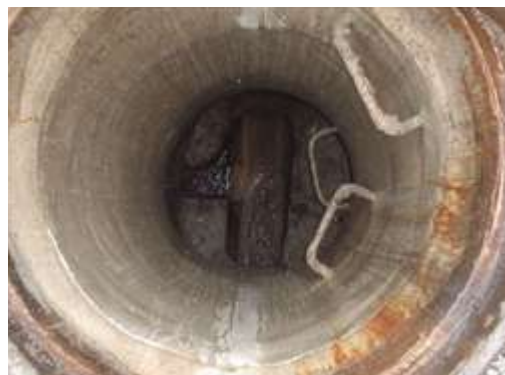
Top View

Frame leaks. Adjustment and Barrel infiltration. Bench debris.

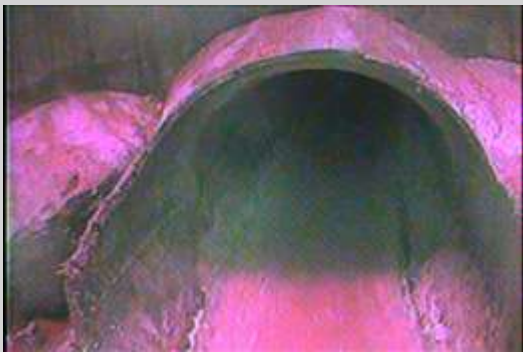
18 in. Circular Gravity Sewer Pipe Out @ 12 O'Clock

Invert Depth: **12.64** (ft.) Flow Characteristics: **Fast**

Infiltration: **None** Pipe Seal Cond: **Unknown**

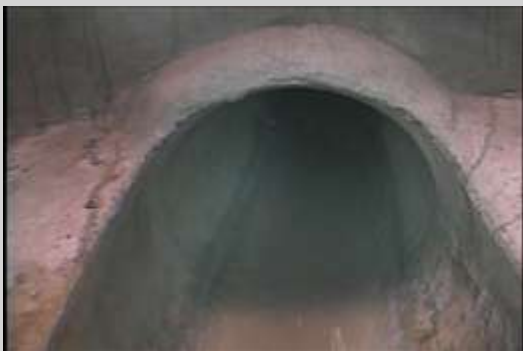
18 in. Circular Gravity Sewer Pipe In @ 6 O'Clock

Invert Depth: **12.42** (ft.) Flow Characteristics: **Fast**

Infiltration: **None** Pipe Seal Cond: **Sound**

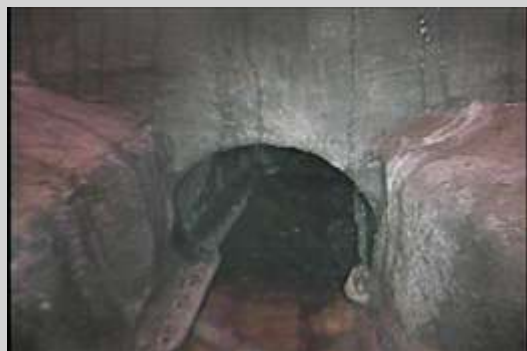
8 in. Circular Gravity Sewer

Invert Depth: **12.09** (ft.) Flow Characteristics: **Slow**

Infiltration: **None**
